**Flood Control Project Maintenance
Levee Inspections**

Fall 2016 Levee Maintenance Deficiency Summary Report

Reclamation District No. 0544 Upper Roberts Island

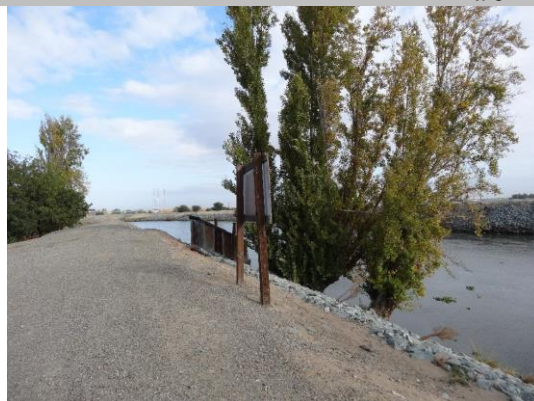
Photo 1 of 2 : UCIP_FA_2016_41906_41713.jpg

LM Start	0.01	Rating **	M	Issue No.	172
LM End	0.01	Issue Type +	En	Location *	N/A
Category	Supplemental			GPS Latitude/Longitude	
				Start	End
Item	DWR UCIP Field Study			37.870356 °	37.870356 °
				-121.329852 °	-121.329852 °
DWR ID					
Comment Code					
Inspector Comment					
FS_ID:41906					
DS_ID:22640					
EP_NO: 4116					
Repair Type: Non-Urgent					
Crossing Status: Found					
UCIP Comments: Need to contact owner to determine status.- a signboard on waterside shoulder and across the river.- no indicators on landside.					
FIELD_STRUCT_DESC: 8-5/8-inch steel gas line through the levee, 3.9 feet below the crown and under the river channel. Waterward slope rock revetted. (App. No. 4116 - PG&E) O&M Manual SJR 007, April 1964.					
FS Date: 10/29/2013

WS view: a signboard indicating a gasline on levee shoulder.

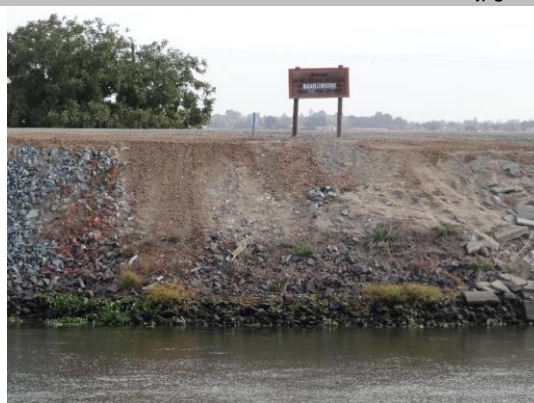
Photo 2 of 2 : UCIP_FA_2016_41906_41712.jpg

WS view: a signboard indicating a gasline across the river channel.

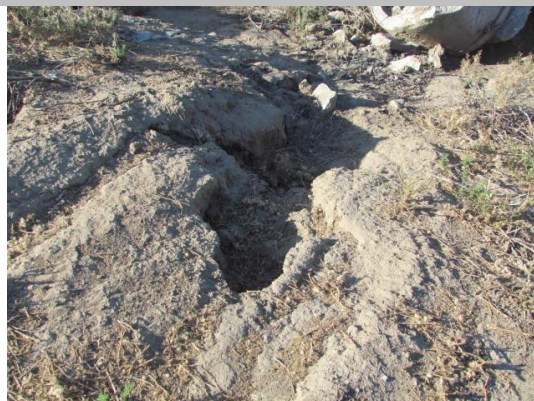
Photo 1 of 1 : FA_2016_RD0544_108_118_20160929_00072.jpg

LM Start	0.06	Rating **	U	Issue No.	118
LM End	0.06	Issue Type +	Ma	Location *	LS
Category	Earthen Levee			GPS Latitude/Longitude	
				Start	End
Item	Erosion / Bank Caving			37.869570 °	37.869570 °
				-121.329556 °	-121.329556 °
DWR ID	DWR_RD0544_01_f_2015_118				
Comment Code					
E1 : Note and monitor erosion site.					
Inspector Comment					
Finger erosion noted on landward slope.

Looking west at landside erosion for shoulder to middle of levee slope.

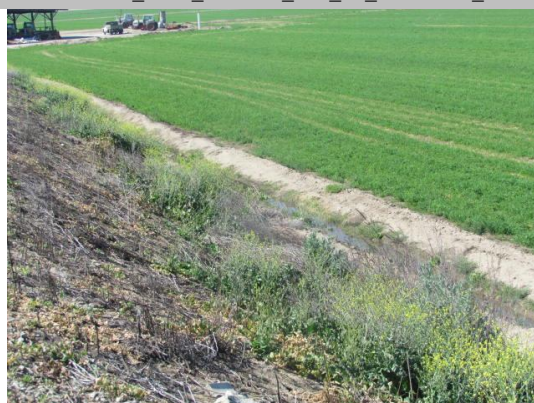
Photo 1 of 1 : FA_2016_RD0544_108_85_20160929_00049.jpg

Looking southwest at Irrigation ditch at landward toe.

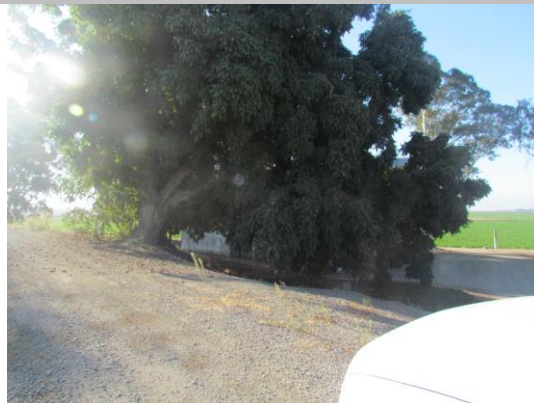
Photo 1 of 1 : FA_2016_RD0544_108_2_20161107_00131.jpg

Looking southwest at untrimmed tree on landward slope.

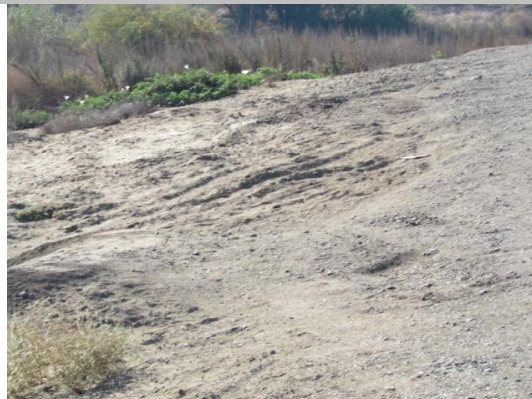
Photo 2 of 3 : FA_2016_RD0544_108_119_20160929_00074.jpg

LM Start	1.50	Rating **	U	Issue No.	119 (cont)	
LM End	1.51	Issue Type +	Ma	Location *	WS	
Category	Earthen Levee			GPS Latitude/Longitude		
				Start		End
Item	Slope Stability			37.854844 °		37.854564 °
				-121.321090 °		-121.321031 °
DWR ID	DWR_RD0544_01_f_2015_119					
Comment Code						
S3 : Repair the levee slope damaged by vehicle traffic and prevent access where possible.						
Inspector Comment						
Damaged levee slope due to fishermen using slope as a ramp.

Looking east at damaged waterward slope fall 2015.

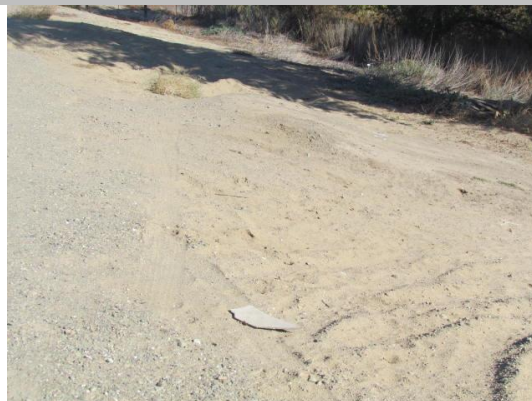
Photo 3 of 3 : FA_2016_RD0544_108_119_20160929_00075.jpg

Looking southeast at damaged waterward slope fall 2015

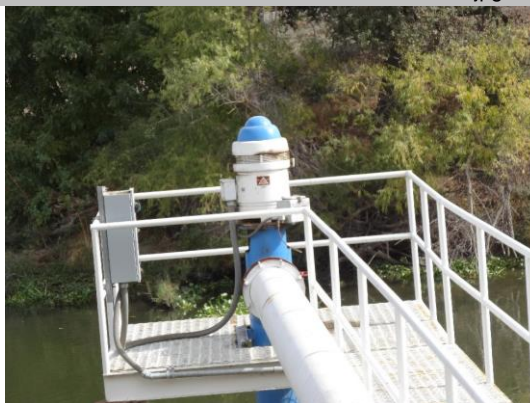
Photo 2 of 2 : UCIP_FA_2016_23945_42006.jpg

WS view: steel pipe, walkway to the pump, and pump on steel pile structure in the stream.

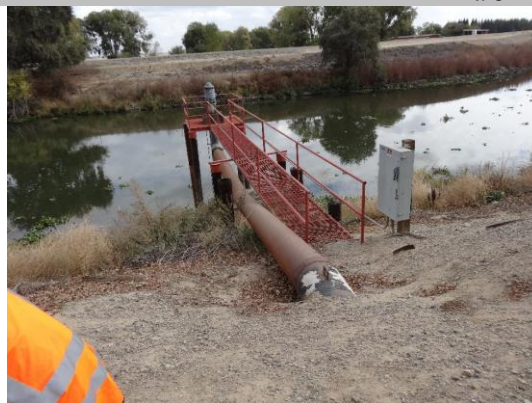
Photo 1 of 2 : UCIP_FA_2016_23946_42017.jpg

LM Start	2.26	Rating **	U	Issue No.	170
LM End	2.26	Issue Type +	En	Location *	CR
Category	Supplemental			GPS Latitude/Longitude	
				Start	End
Item	DWR UCIP Field Study			37.848052 °	37.848052 °
				-121.324846 °	-121.324846 °
DWR ID					
Comment Code					
Inspector Comment					
FS_ID:23946 DS_ID:22651 EP_NO: 3300 Repair Type: Urgent Crossing Status: Found UCIP Comments: - erosion on landside and waterside levee slopes due to the pipe leakage.- 1.5-inch electric conduit FIELD_STRUCT_DESC: 18-inch steel pipe through the levee, 3.5 feet below the crown, pump mounted on pile structure in the stream. Siphon breaker on the landward slope. Concrete standpipe and service pole at the toe of the landward slope. (App. No. 3300-Lloyd Phelps) O&M Manual SJR 007, April 1964. FS Date: 10/29/2013

WS view: exposed pipe, walkway to pump, pump on pile structure in the stream.

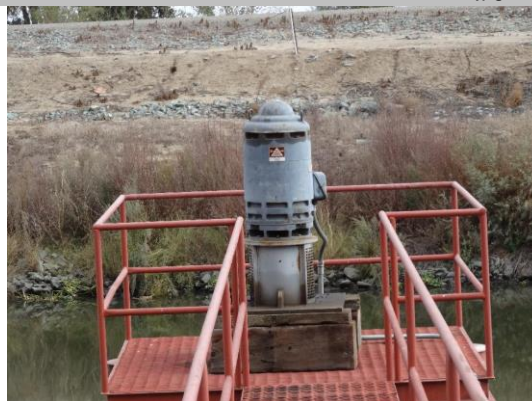
Photo 2 of 2 : UCIP_FA_2016_23946_42016.jpg

WS view: walkway to pump, pump on pile structure in the stream.

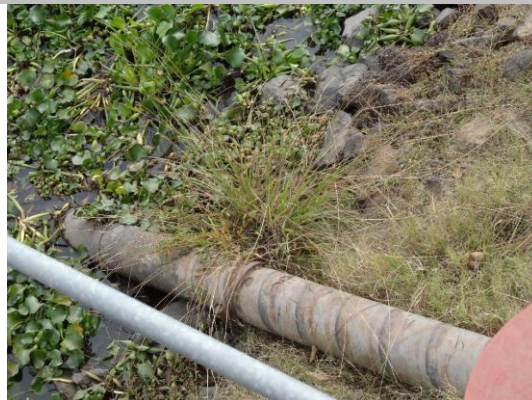
Photo 1 of 2 : UCIP_FA_2016_24887_44830.jpg

LM Start	2.26	Rating **	M	Issue No.	164
LM End	2.26	Issue Type +	En	Location *	CR
Category	Supplemental			GPS Latitude/Longitude	
				Start	End
Item	DWR UCIP Field Study			37.848029 °	37.848029 °
				-121.324851 °	-121.324851 °
DWR ID					
Comment Code					
Inspector Comment					
FS_ID:24887 DS_ID:22652 EP_NO: 13554 Repair Type: Non-Urgent Crossing Status: Found UCIP Comments: - levee slope erosion on landside.- needs cleaning of siphon breaker. FIELD_STRUCT_DESC: 12-inch steel pipe, pump in concrete standpipe on drainage ditch on landside. Siphon breaker in steel riser on waterside. (App. No. 13554 - Phelps; 12/7/82), O&M Manual SJR 007, April 1964. FS Date: 10/29/2013

WS view: steel pipe immersed into the stream.

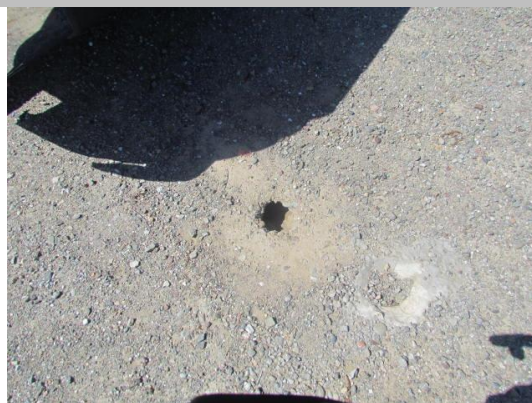
Photo 2 of 2 : FA_2016_RD0544_108_34_20160929_00026.jpg

Looking at rodent hole on levee crown.

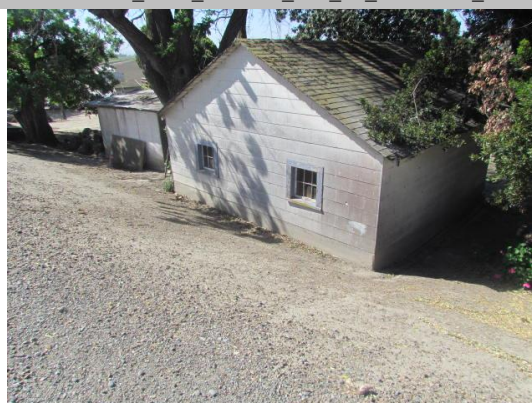
Photo 1 of 1 : FA_2016_RD0544_108_67_20160929_00046.jpg

Looking southeast at building at landward toe.

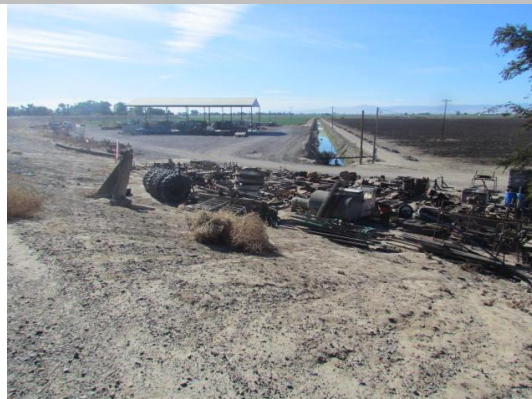
Photo 1 of 1 : FA_2016_RD0544_108_68_20160929_00047.jpg

Looking west at equipment at landward toe.

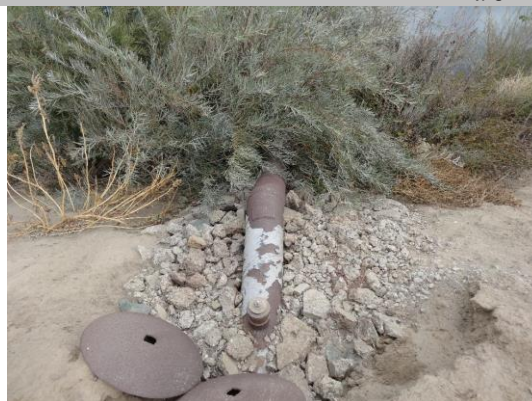
Photo 1 of 2 : UCIP_FA_2016_46671_44836.jpg

WS view: exposed steel pipe and siphon breaker on levee slope.

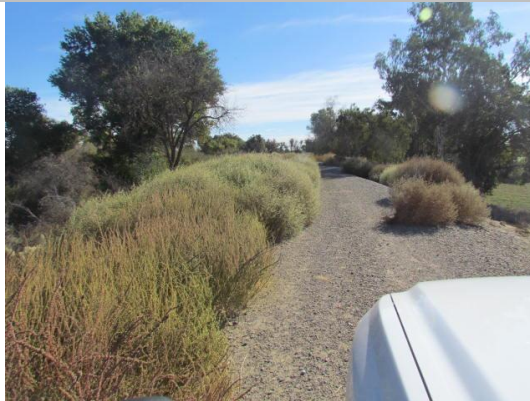
Photo 1 of 1 : FA_2016_RD0544_108_99_20160929_00060.jpg

Looking south at dense vegetation on waterward shoulder and slope.

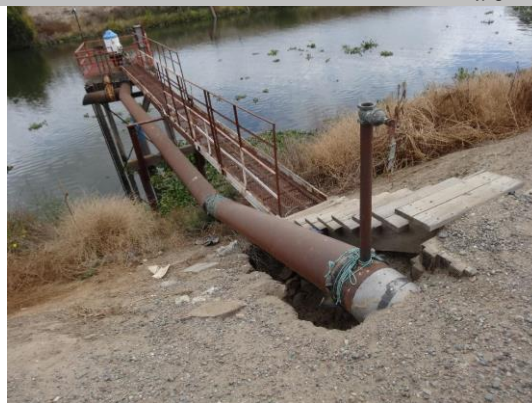
Photo 1 of 2 : UCIP_FA_2016_24889_44839.jpg

WS view: exposed pipe, walkway to pump, and pump on pile structure in the stream.

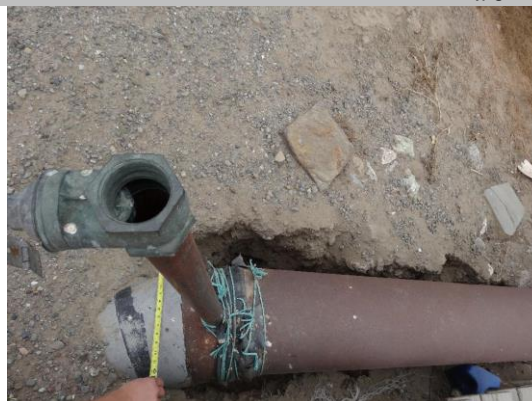
Photo 2 of 2 : UCIP_FA_2016_24889_44838.jpg

WS view: exposed pipe, air relief valve, and huge erosion on levee slope.

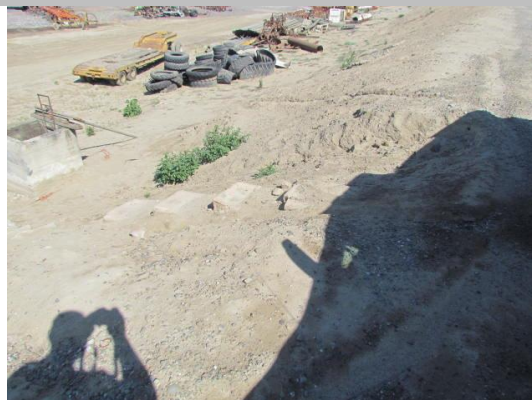
Photo 1 of 2 : FA_2016_RD0544_108_60_20160929_00041.jpg

Looking north at slope damage on landside slope.

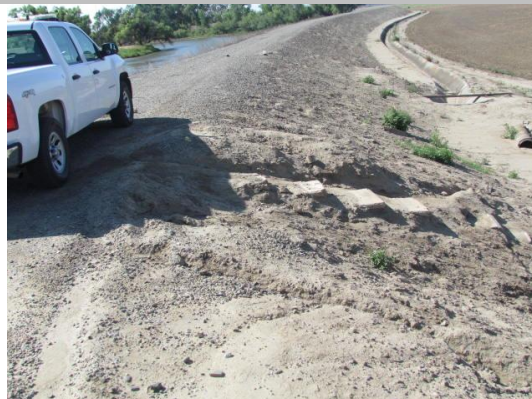
Photo 2 of 2 : FA_2016_RD0544_108_60_20160929_00042.jpg

Looking south at slope damage on landside slope.

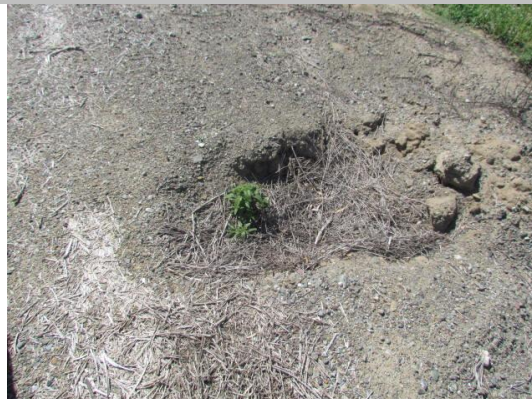
Photo 2 of 2 : FA_2016_RD0544_108_107_20160929_00066.jpg

Looking west at depression on landward shoulder.

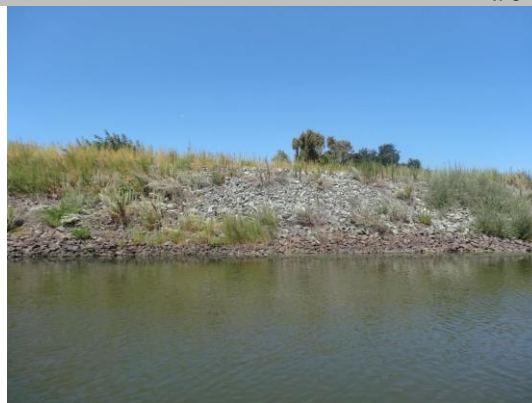
Photo 1 of 2 : SJR2016_RD0544U01RM49.67_1.jpg

Front view of the erosion.

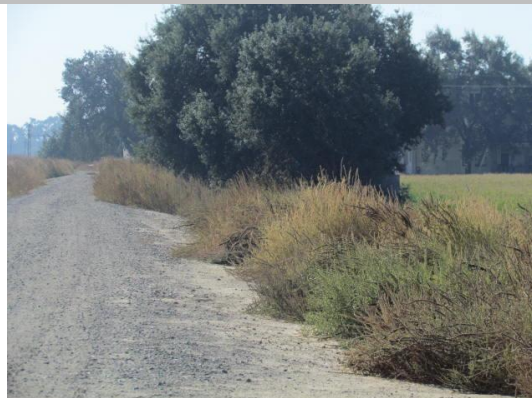
Photo 1 of 1 : FA_2016_RD0544_108_47_20160929_00037.jpg

Looking south at dense veg on landward slope fall 2015.

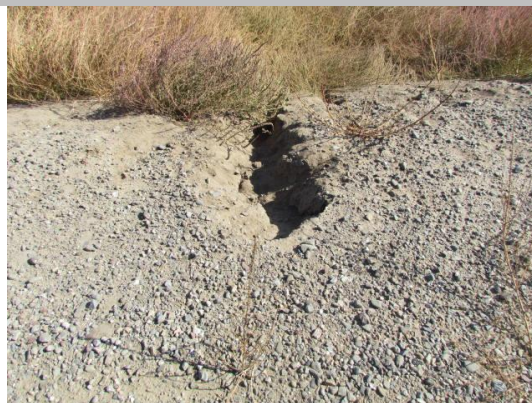
Photo 1 of 1 : FA_2016_RD0544_108_76_20160929_00048.jpg

Looking east at slope damage on waterward slope.

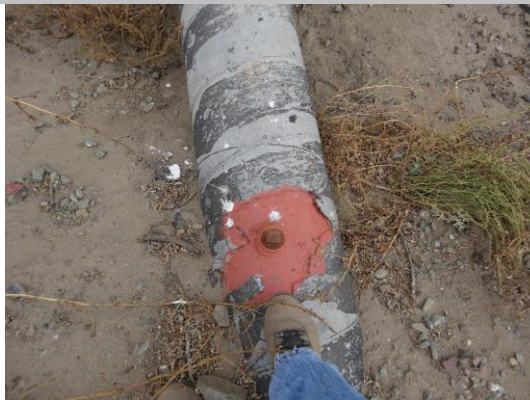
Photo 2 of 2 : UCIP_FA_2016_43026_44844.jpg

WS view: pipe daylights on levee slope. Siphon breaker removed and plugged.

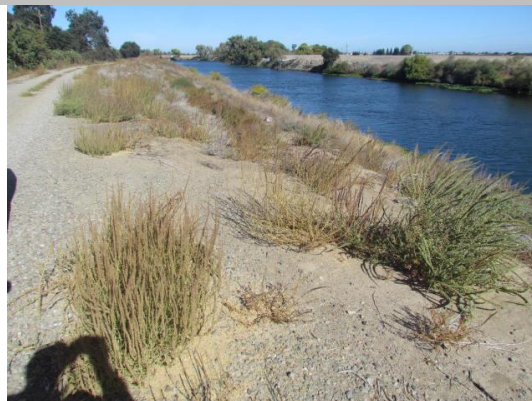
Photo 1 of 1 : FA_2016_RD0544_108_37_20160929_00028.jpg

Looking north at ramp on waterward slope.

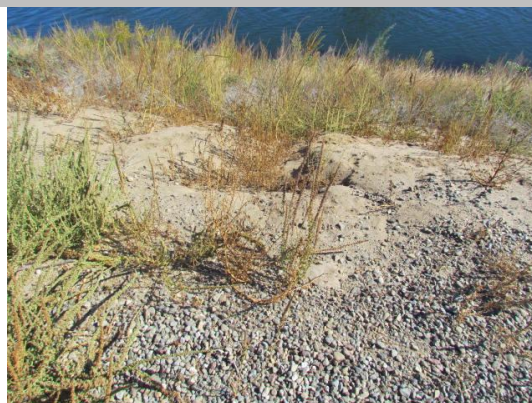
Photo 1 of 1 : FA_2016_RD0544_108_50_20160929_00039.jpg

Looking east at erosion on waterward slope.

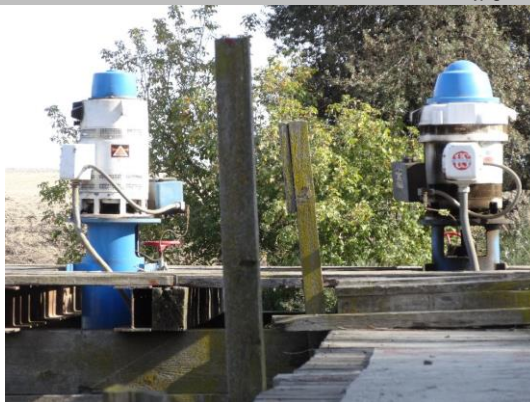
Photo 2 of 2 : UCIP_FA_2016_24893_44857.jpg

WS view: pumps, walkway to pump, and pile structure in the stream.

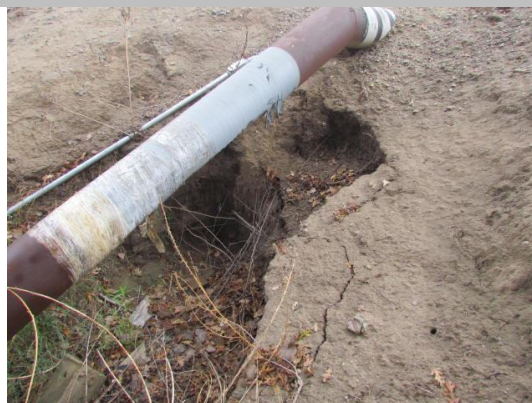
Photo 1 of 2 : FA_2016_RD0544_108_28_20160929_00021.jpg

Looking northeast at erosion around irrigation pipe on landside slope.

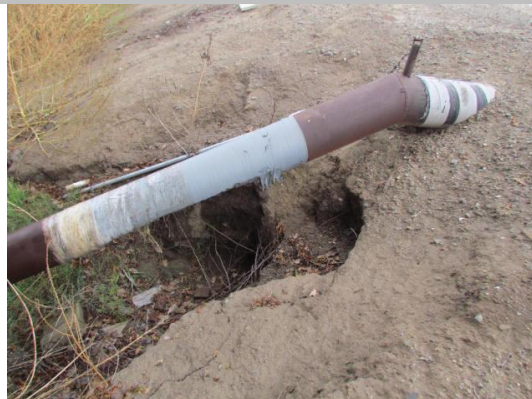
Photo 2 of 2 : FA_2016_RD0544_108_28_20160929_00022.jpg

Looking north at erosion around irrigation pipe on landside

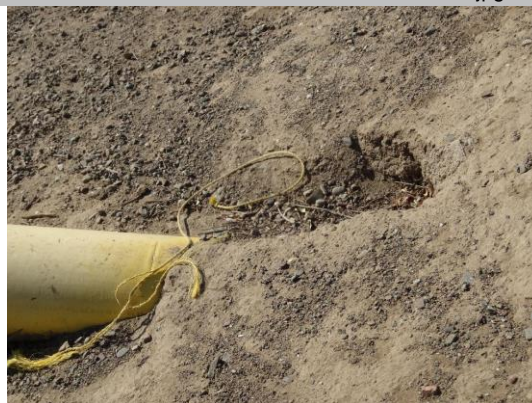
Photo 2 of 2 : UCIP_FA_2016_24894_44863.jpg

WS view: exposed steel pipe and a small depression on levee slope.
May be due to leaky pipe.

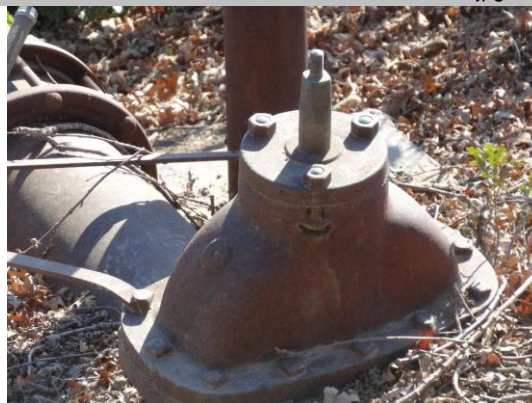
Photo 2 of 2 : UCIP_FA_2016_42962_42876.jpg

WS view: gate valve without handwheel on levee slope.

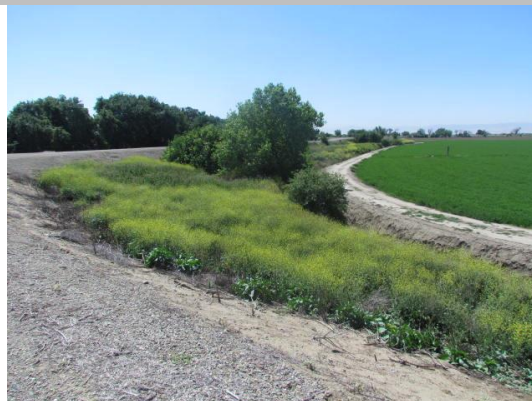
Photo 2 of 2 : FA_2016_RD0544_108_33_20160929_00024.jpg

Looking southwest at dense vegetation at landward slope and toe.(Spring 2015)

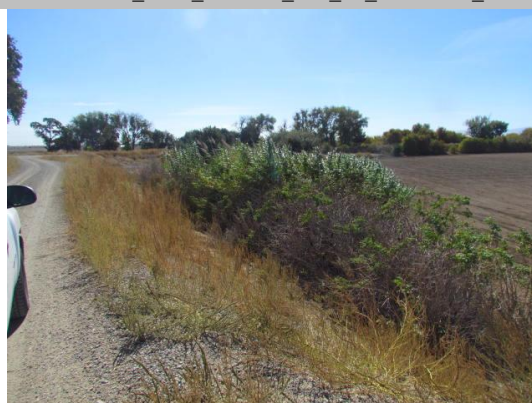
Photo 1 of 1 : FA_2016_RD0544_108_35_20160929_00027.jpg

Looking south at bamboo on landward slope and toe.

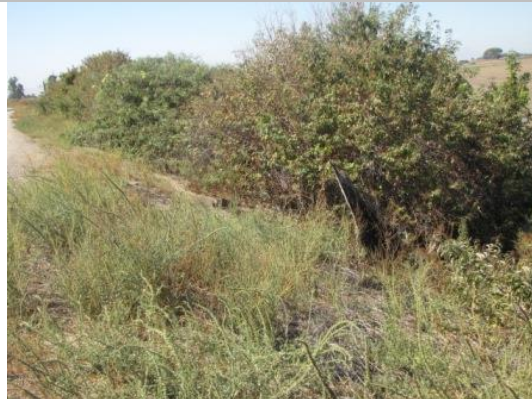
Photo 2 of 2 : FA_2016_RD0544_108_18_20160929_00016.jpg

Looking south at elderberries on landside slope and toe.

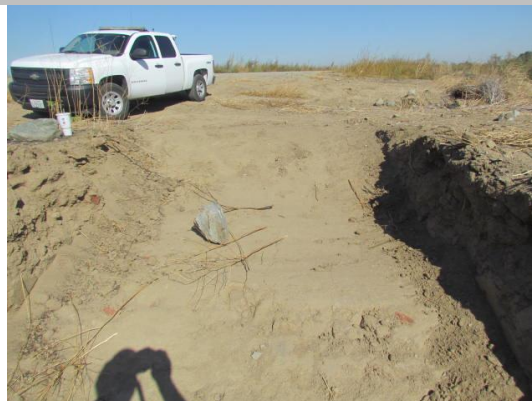
Photo 1 of 4 : FA_2016_RD0544_108_121_20160929_00076.jpg

Looking west at excavation on waterward berm.

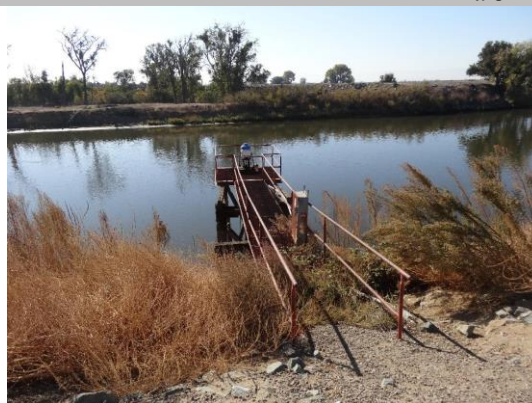
Photo 1 of 2 : UCIP_FA_2016_24233_42872.jpg

WS view: pump on pile structure, walkway to the pump on levee slope.

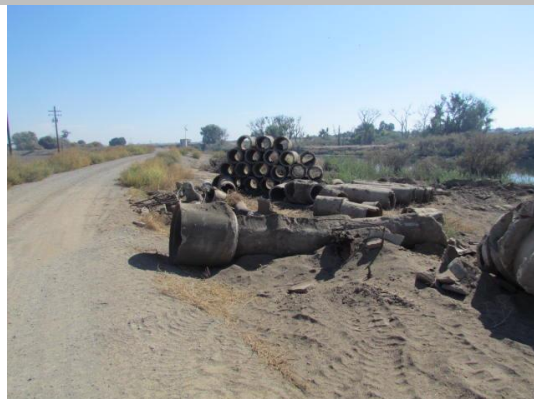
Photo 1 of 1 : FA_2016_RD0544_108_122_20160929_00080.jpg

Looking northeast at concrete pipes stockpiled at waterward shoulder and slope.

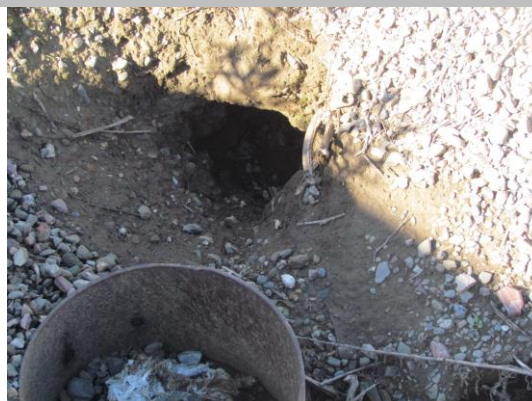
Photo 1 of 6 : FA_2016_RD0544_109_8_20161107_00086.jpg

Looking at hole next to siphon on waterward shoulder. (Fall 2016)

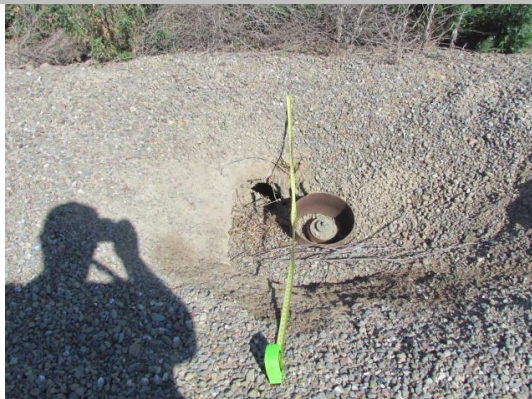
Photo 4 of 6 : FA_2016_RD0544_109_8_20160929_00010.jpg

Looking east at caving around siphon on waterside shoulder. (Spring 2012)

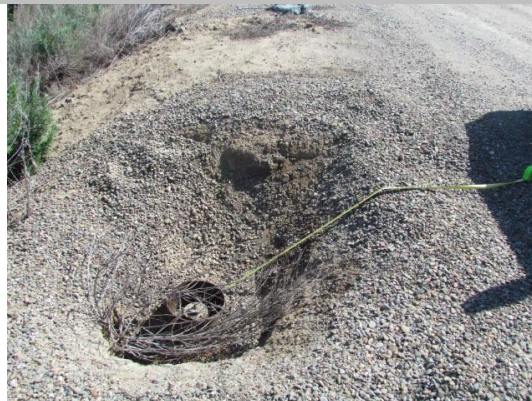
Photo 6 of 6 : FA_2016_RD0544_109_8_20160929_00013.jpg

Looking south at caving around siphon on waterside shoulder. (Spring 2012)

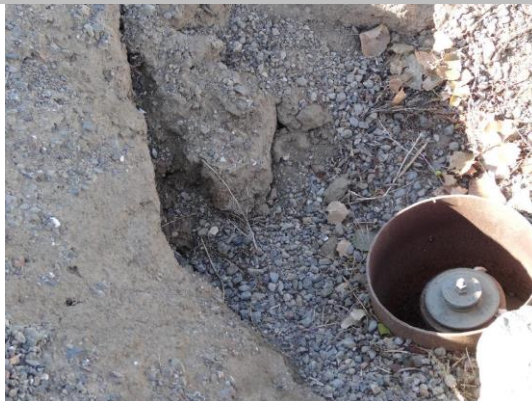
Photo 2 of 2 : UCIP_FA_2016_24903_44881.jpg

WS view: depression on levee slope around siphon breaker. Siphon breaker in steel pipe riser.

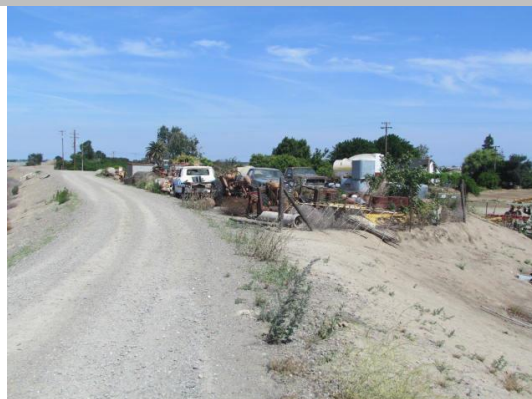
Photo 3 of 4 : FA_2016_RD0544_109_18_20160929_00026.jpg

Looking southwest at vehicles and farm equipment stored on landside landing. (spring 2014)

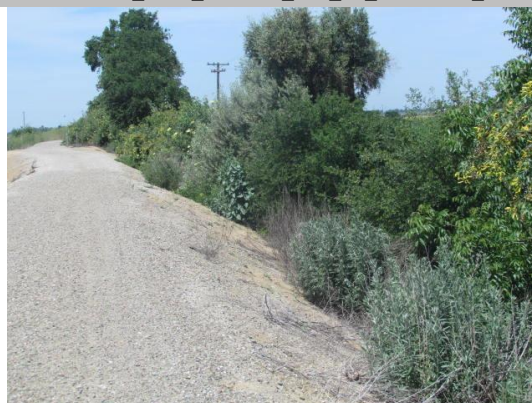
Photo 2 of 2 : FA_2016_RD0544_109_49_20160929_00042.jpg

Looking southwest at dense vegetation on landward slope and toe.

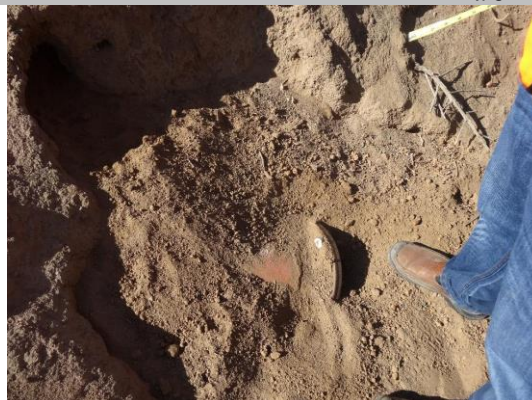
Photo 2 of 2 : UCIP_FA_2016_46674_44889.jpg

LS view: steel pipe on levee slope with opened end. Levee slope erosion around the pipe.

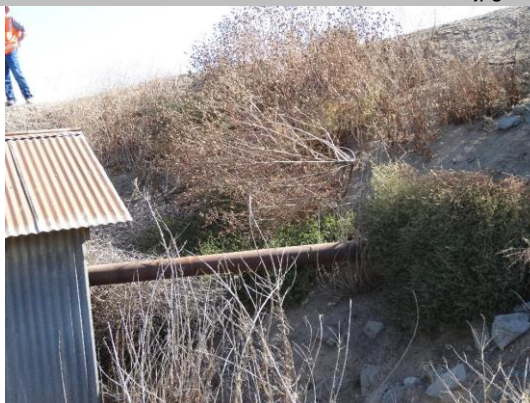
Photo 2 of 2 : UCIP_FA_2016_24907_44894.jpg

LS view: pipe daylights on levee slope.

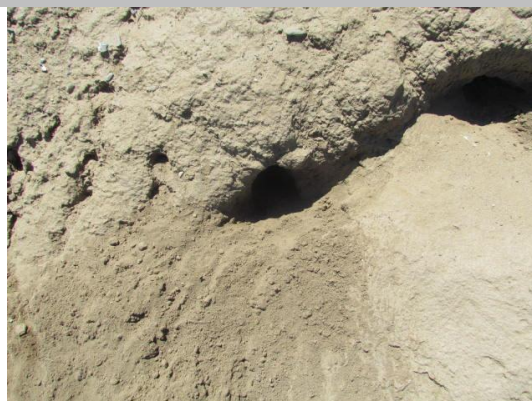
Photo 1 of 1 : FA_2016_RD0544_109_58_20160929_00050.jpg

Looking at typical rodent holes on landward slope.

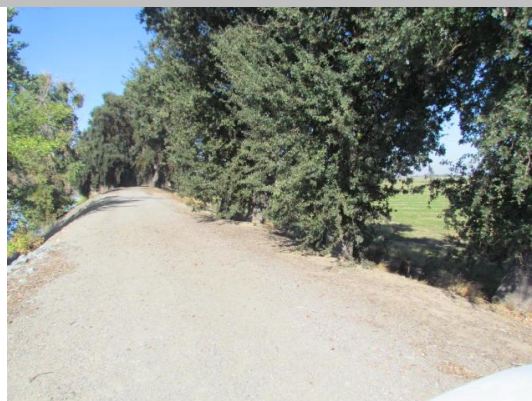
Photo 1 of 1 : FA_2016_RD0544_109_59_20160929_00051.jpg

Looking southwest at untrimmed trees on landward slope and toe fall 2015.

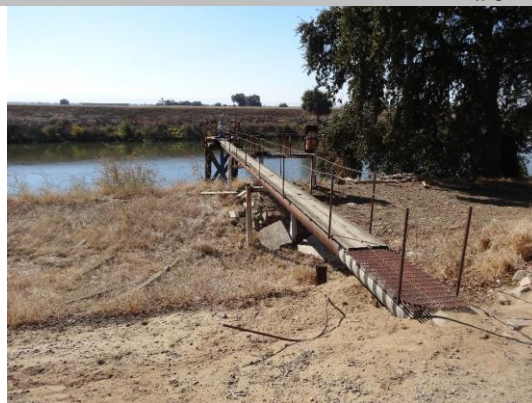
Photo 1 of 2 : UCIP_FA_2016_41731_42954.jpg

WS view: pipe, walkway, and pump on pile structure.

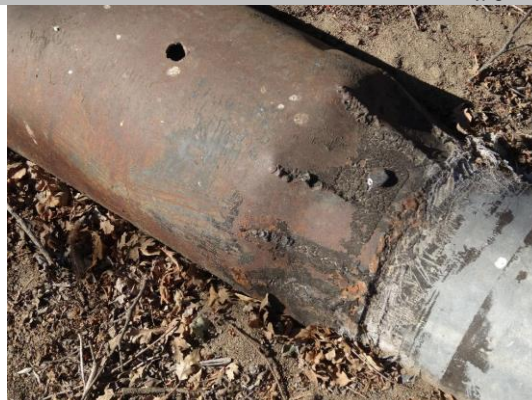
Photo 2 of 2 : UCIP_FA_2016_24293_42964.jpg

WS view: 12" steel pipe connected to 10" pipe. Holes on pipe top found.

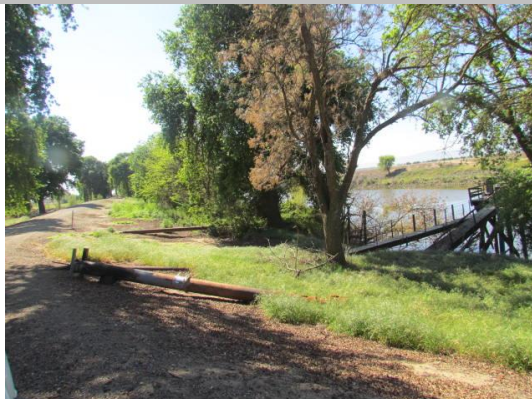
Photo 1 of 1 : FA_2016_RD0544_109_51_20160929_00045.jpg

Looking north at old pump shaft and pipe on waterward slope.

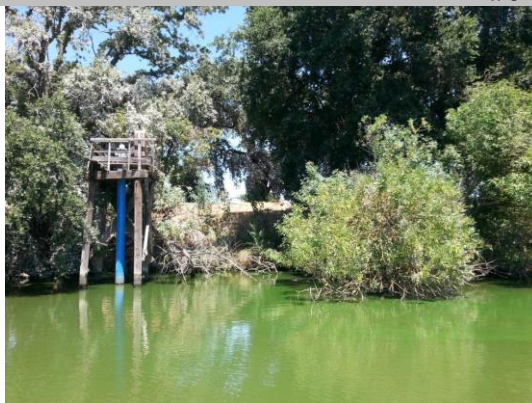
Photo 1 of 2 : SJR2016_RD0544U02RM33.21_1.jpg

Front view of the erosion site. View is partially blocked by the pump structure and vegetation at the site.

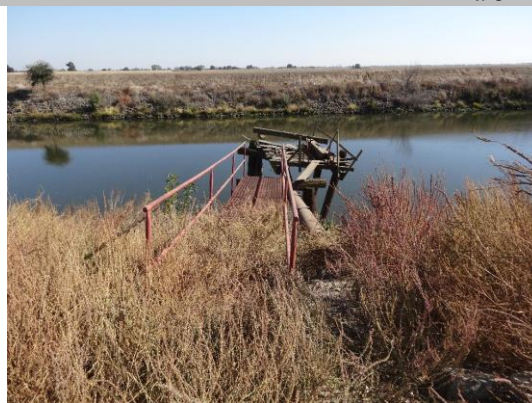
Photo 1 of 2 : UCIP_FA_2016_24295_42972.jpg

WS view: dilapalated walkway and pile structure. Pump removed.

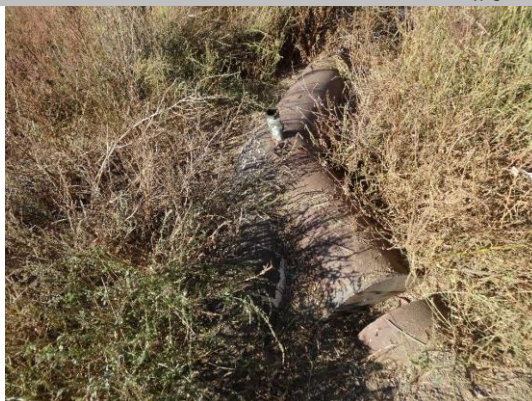
Photo 2 of 2 : UCIP_FA_2016_24295_42971.jpg

LS view: steel pipe cut out and discontidued (bottom).

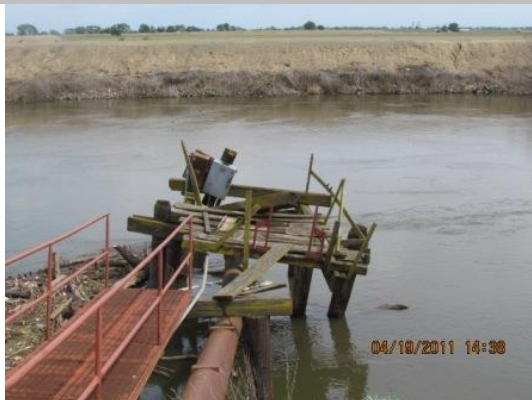
Photo 1 of 3 : FA_2016_RD0544_109_17_20160929_00023.jpg

Looking east at dilapidated pump platform.

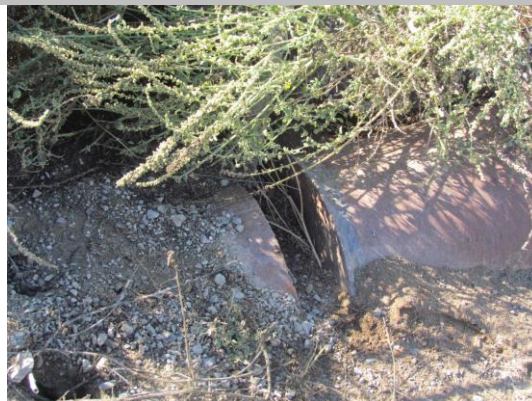
Photo 3 of 3 : FA_2016_RD0544_109_17_20161107_00091.jpg

Looking at abandoned pipe on landward slope.

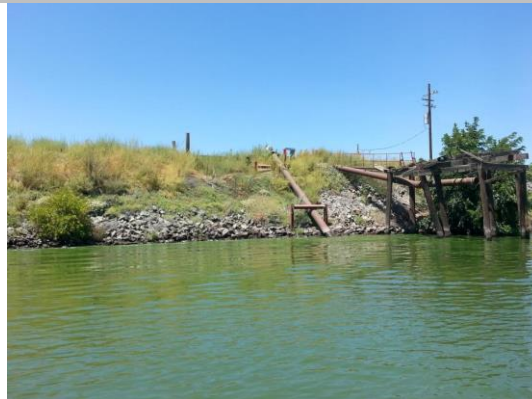
Photo 1 of 2 : SJR2016_RD0544U02RM33_1.jpg

Front view of the erosion site.

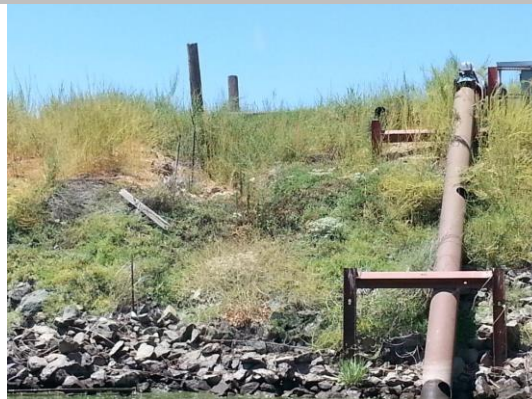
Photo 2 of 2 : SJR2016_RD0544U02RM33_3.jpg

Close view of the erosion. Vegetation around the site is visible.

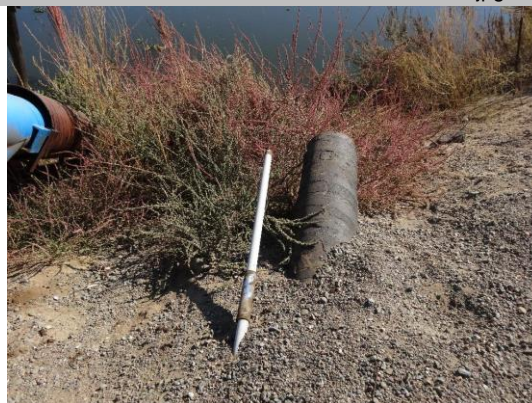
Photo 1 of 2 : UCIP_FA_2016_24297_42977.jpg

WS view: steel pipe and electric conduit on levee shoulder.

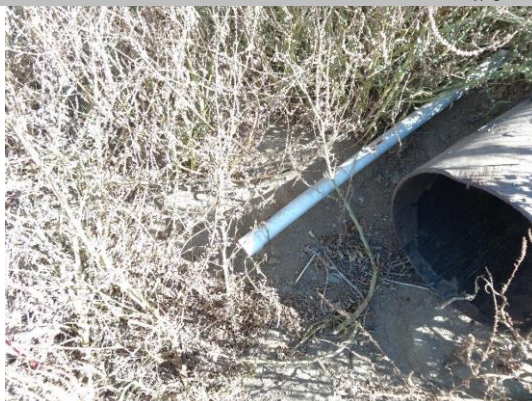
Photo 2 of 2 : UCIP_FA_2016_24297_42976.jpg

LS view: steel pipe and electric conduit on levee shoulder.

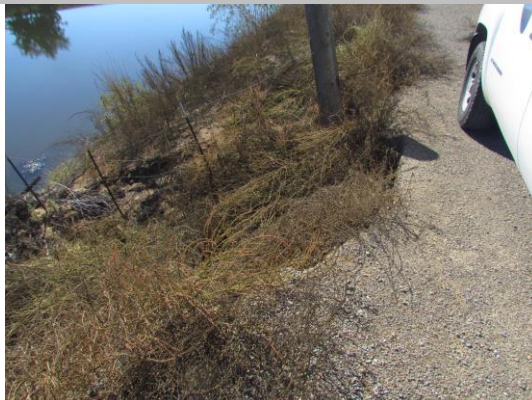
Photo 1 of 3 : FA_2016_RD0544_109_69_20161107_00093.jpg

Looking south at erosion on waterward shoulder and slope.

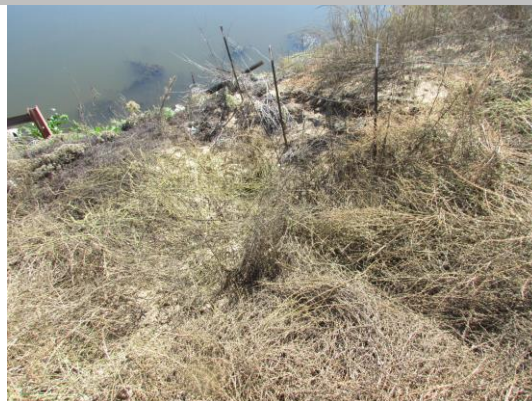
Photo 3 of 3 : FA_2016_RD0544_109_69_20161107_00094.jpg

Looking south at waterward erosion.

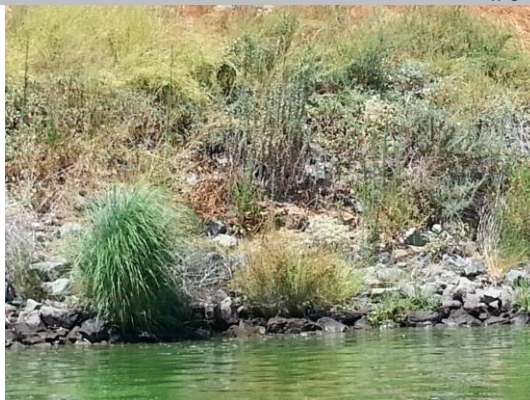
Photo 2 of 2 : SJR2016_RD0544U02RM32.91_3.jpg

Close view of the erosion.

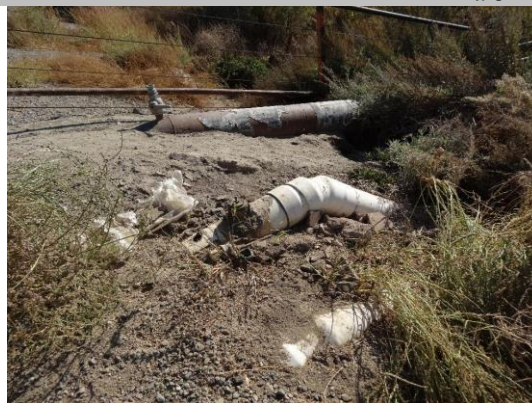
Photo 1 of 2 : UCIP_FA_2016_24908_44898.jpg

WS view: 12" steel pipe (top), two 8" white pvc pipes (bottom) on levee shoulder.

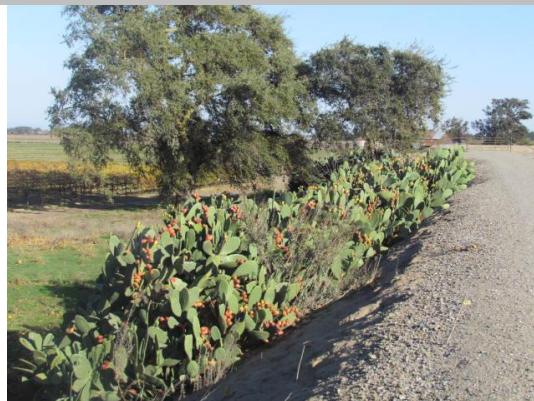
Photo 2 of 3 : FA_2016_RD0544_109_36_20160929_00036.jpg

Looking north at cactus on landside slope and toe spring 2015

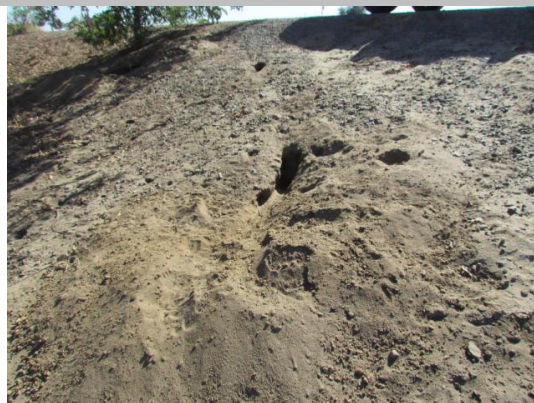
Photo 2 of 2 : FA_2016_RD0544_109_67_20160929_00056.jpg

Looking north at typical view of rodent holes on landward slope.

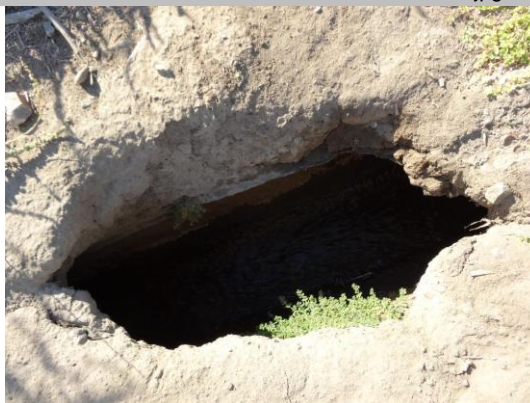
Photo 2 of 2 : UCIP_FA_2016_46064_43004.jpg

WS view: close view of levee slope with pits and holes.
